Zero error culture – an attainable goal?

Cross-functional contribution to BIM Community 2017 in Aarhus

Stephan Lange | Quality Manager
Aircraft component Services | 04th Oct 2017

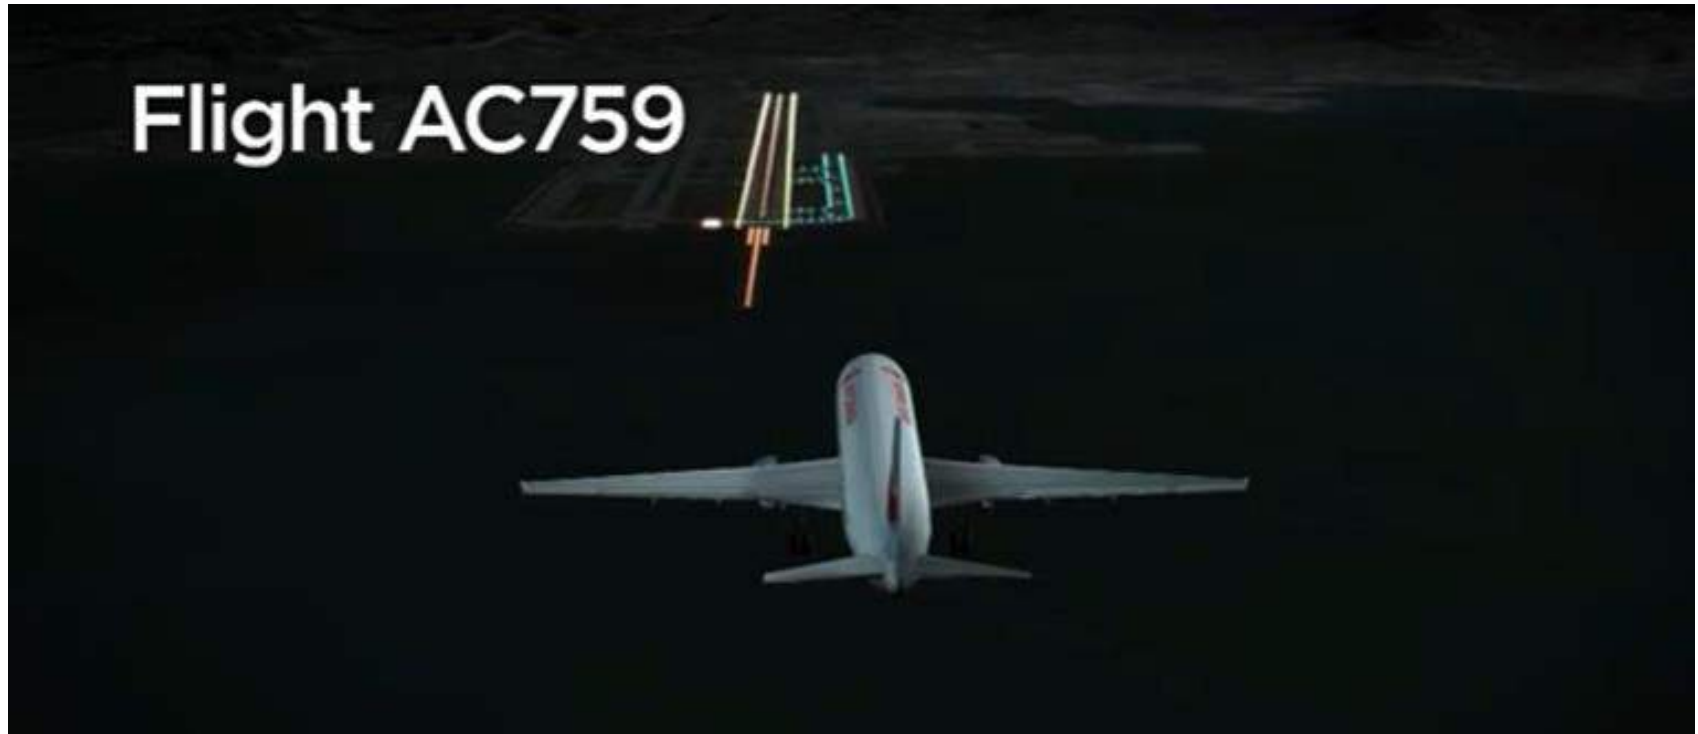
ACA 759 – mental set issue?

- Runway 28L (left) was closed and marked accordingly.
- ACA 759 was cleared to land on RWY 28R (right) but somehow mistakenly thought that the Taxiway C is RWY 28R.
- Taxiway “C” occupied with **4 Aircrafts**

No investigation report yet. Could have been biggest air disaster ever.

Likely cause: low situational awareness due to mental set of 2 RWY and target fixation.

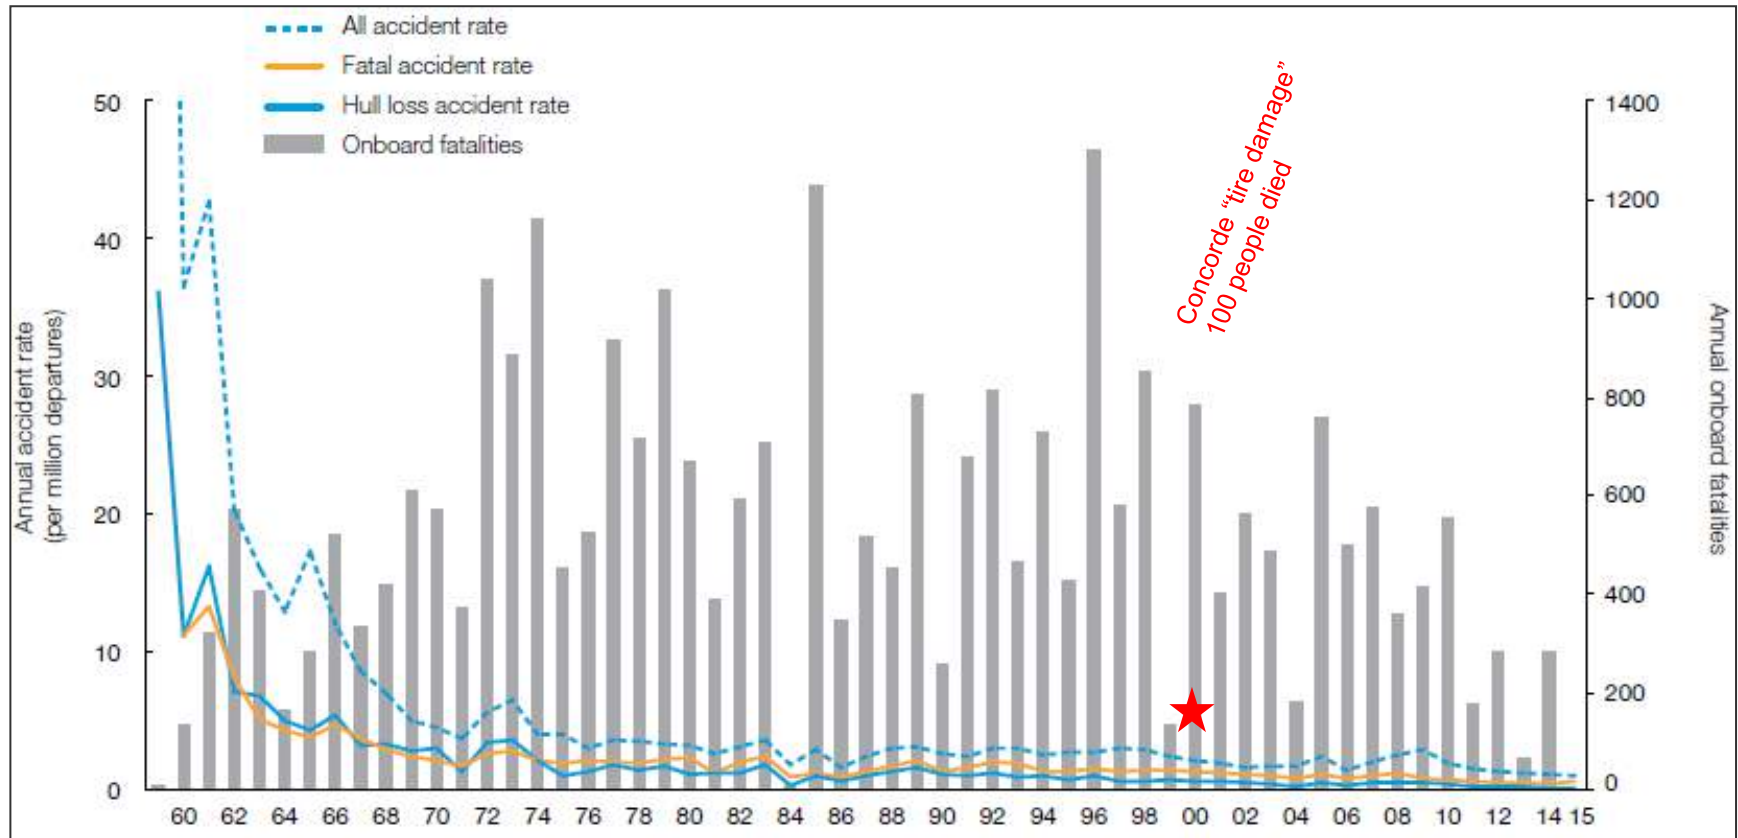
Worldwide accident rates and onboard fatalities by year 1959 through 2015*

- Significant decrease of flight accidents past 60 years caused by
 - technical improvements and increase of reliability & cockpit automation (1960s)
 - first Human factor studies late 70s which became mandatory part of pilot qualification syllabus as „Crew Resource Management Training focusing on non technical skills (90s)
 - 3.7 Billion passengers in 2017 expecting to grow to 7 Billion in 2037 (IATA)

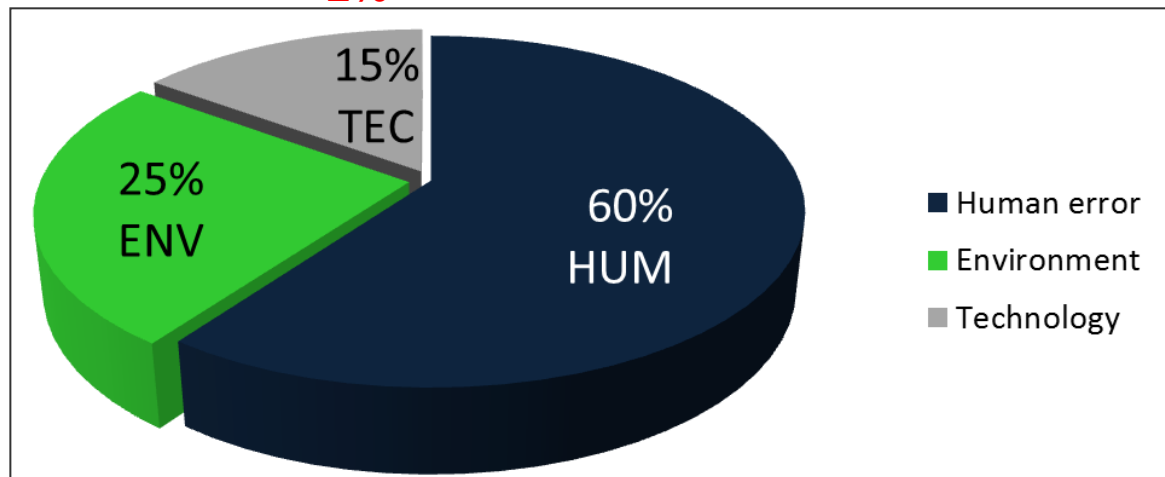
Accidents by Phase of flight and Causes of aircraft accidents

- ~ 50% of fatal accidents during final approach/landing although this phase takes 4% time only
- ~ 50% to 75% of all accidents caused by human error

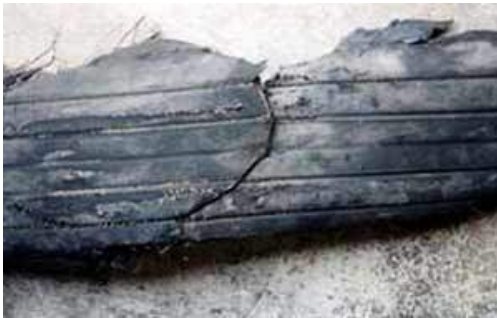
Debris with transverse cut 32cm

According to french investigation report (BAE) catastrophe was caused by 43cm stainless metal strip which laid on Runway. Contrary to the original part which was made of aluminium this metal strip was made of titanium. If tyre had rolled over the original part, the tyre would have been damaged.

The metal strip which had fallen from another aircraft DC-10 (US operator) which had taken off 5min earlier. Investigation revealed that the maintenance staff deviated from maintenance instructions. Instead of using an aluminium part they used a titanium metal strip. Neither metal strip nor riveting work performed to assembly the strip was in accordance to maintenance manual of the OEM.

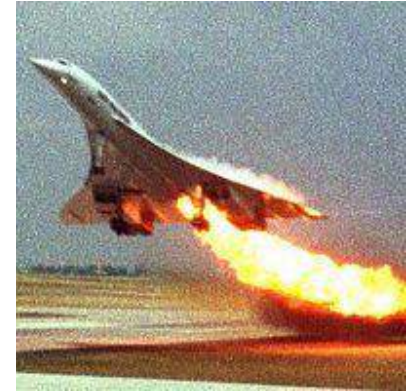
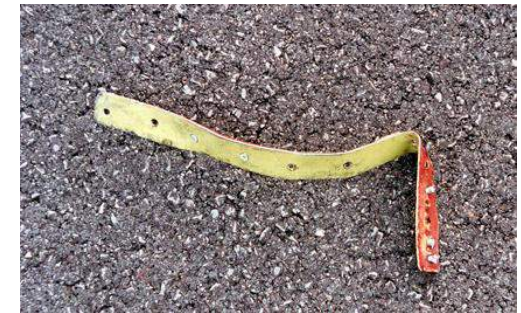
Metal strip on Rwy

The titanium metal strip fell off from a another aircraft DC-10 (US operator) which had taken off 5min earlier. Investigation revealed that the maintenance staff deviated from maintenance instructions. Instead of using an aluminium part they used a titanium metal strip. Neither metal strip nor riveting work performed to assembly the strip was in accordance to maintenance manual of the OEM.
